Property ID:	3111
Property Address:	4442 JOSEPHINE ST.
Owner:	RICK KEENAN
Phone:	Cell- 720-422-5043 / W-303-423-6000 / H-303-431-8000

## Consent For Access To Property

Address: 4442 Josephine St.		Structure:	House							
Date: 8/11/05		Direction:	West							
Investigator: CM, WH										
Time Started: 8:20 am										
Drawing Number	Photo Number	Painted Surface	Material	Color	Total Area of Element (units ft^2)	Percent Deteriorated	Deteriorated Area (units ft^2)	XRF #	XRF Value	pos/neg
		front porch landing	concrete	green	43.88	20%	8.78	190	0.04±0.05	neg
1	1-2	front porch fascia and soffit	wood	white	24.20	50%	12.10	189	29±1.8	pos
2	1-2	front porch decorative trim	wood	white			1.00	see 189	29±1.8	pos
		front porch rail base	wood	tan	2.30	20%	0.46	187	0.32±0.19	neg
3	3	front porch rail (under hand rail)	wood	tan	3.36	30%	1.01	188	49+-13	pos
4	4	wall	stucco	white	219.50	10%	21.95	191	29+-10	pos
5	5	window sash frame	wood	white			1.13	192	12+-3.0	pos
6		gable end/trim	wood	white/tan			6.00	see 189	29±1.8	pos

SITE NAME: VASQUEZ BOULEVARD AND I-70

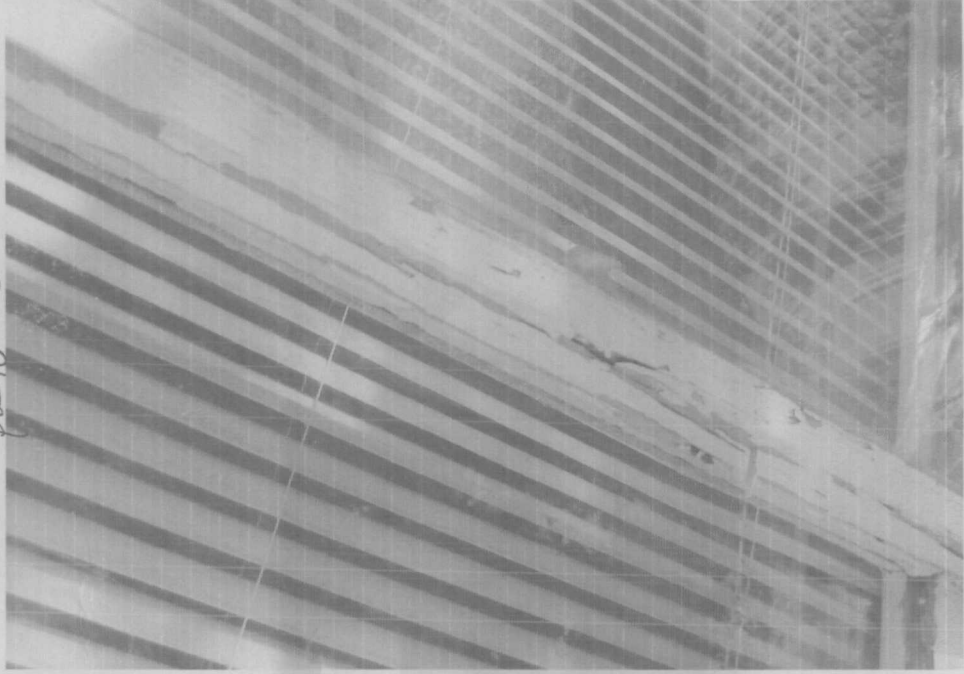
photo 13

Drawing Number	Photo Number	Painted Surface	Material	Color	Total Area of Element (units ft^2)	Percent Deteriorated	Deteriorated Area (units ft^2)	XRF #	XRF Value	pos/neg
13	13	window sash/frame	wood	white			0.59	see 192	12+-3.0	pos
14	14	trim at bottom of gable end	wood	white	9.92	100%	9.92	see 192	12+-3.0	pos
15	15	soffit	wood	white			4.00	see 189	29±1.8	pos
16	16	wall	brick	white	164.20	10%	16.42	see 195	1.9+-0.5	pos
		foundation wall	stucco	white	8.50	100%	8.50	see 194	0.35+-0.27	neg

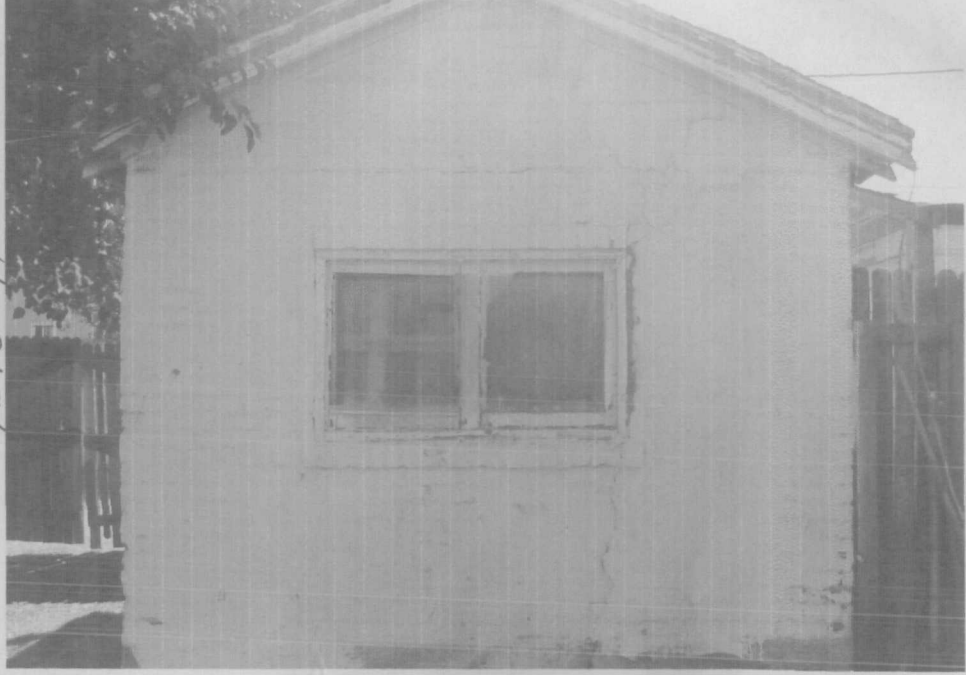
photo 17

Drawing Number	Photo Number	Painted Surface	Material	Color	Total Area of Element (units ft^2)	Percent Deteriorated	Deteriorated Area (units ft^2)	XRF #	XRF Value	pos/neg
17	17	west wall/window frame	brick/wood	white	79.00	20%	15.80	196	24+-10	pos
17	17	west foundation wall	concrete	white	10.00	50%	5.00	197	1.0±0.1	pos
18	18	west soffit/trim	wood	white	13.20	100%	13.20	see 198	28+-9	pos
19	19	north doors (slatted)	wood	white	27.30	100%	27.30	198	28+-9	pos
		north door (panel)	wood	white	14.95	50%	7.48	199	0.08+-0.42	neg
20	20	north soffit/fascia/rafter tails	wood	white	26.70	100%	26.70	see 198	28+-9	pos

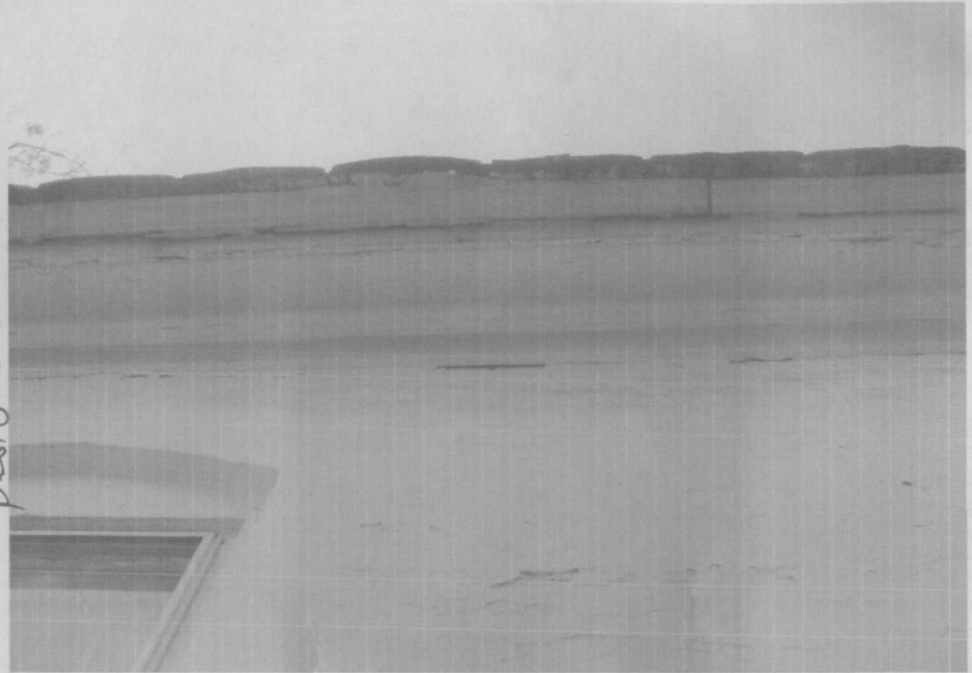
photo 21

Drawing Number	Photo Number	Painted Surface	Material	Color	Total Area of Element (units ft^2)	Percent Deteriorated	Deteriorated Area (units ft^2)	XRF #	XRF Value	pos/neg
21	21	soffit/fascia	wood	white/tan	69.00	50%	34.50	see 189	29±1.8	pos
22	22	wall (back part of house)	brick	white	135.60	30%	40.68	see 195	1.9+-0.5	pos
		foundation wall (back part of house)	concrete	white	28.66	100%	28.66	see 194	0.35+-0.27	neg
23	23	window frame (back)	wood	white	4.08	100%	4.08	see 192	12+-3.0	pos
24	24	basement window frame (back)	wood	grey	5.59	100%	5.59	201	39+-11	
25	25	window sill (front)	wood	tan	0.96	100%	0.96	see 193	11+-2.9	pos
26	26	window frames (2)	wood	white			1.25	see 192	12+-3.0	pos
27	27	wall (front part of house)	stucco	white	292.50	50%	146.25	see 191	29+-10	pos
Address: 4442 Josephine St.		Structure:	garage							
Date: 8/11/05		Direction:	north and west							
Investigator: CM, WH										
Time Started: 8:20 am
